**CULTURAL RESOURCES ASSESSMENT FOR THE
CHANHASSEN ALTERNATIVE URBAN AREA WIDE REVIEW
(AUAR), CHANHASSEN, CARVER COUNTY, MINNESOTA**

**SHPO File No. Pending
The 106 Group Project No. 03-12**

May 2003

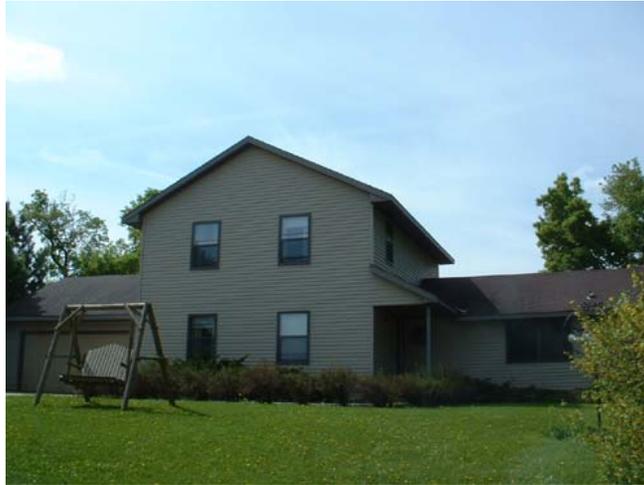
Property 1, House

Field Number	Address	Property Type	Building Types	Date (Estimate)	Description/Integrity
1	1630 Lyman Rd.	Farmstead	House, Dairy Barn, Granary, Garage	c. 1900	The house has been significantly altered with vinyl siding, replacement windows, and additions. The central bay barn has board and batten siding and retains good integrity. The granary, with drop siding, is partially demolished and in a dilapidated state.
2	9111 Audubon Rd.	Farmstead	House (c. 1950), Barn, Granary/Corncrib, Chicken House, Silo, Pole Barns	c. 1910	The house was constructed circa 1950. The gambrel roof dairy barn has board and batten siding and retains good integrity. The granary and corncrib also retain good integrity. The addition of pole barns and the house compromise the overall integrity of the farmstead.
3	9201 Audubon Rd.	House	House, Pole Barn	c. 1940	This small, side-gabled house has replacement windows and fair integrity. It is adjacent to Property 4 and includes a large, metal-sided pole barn.

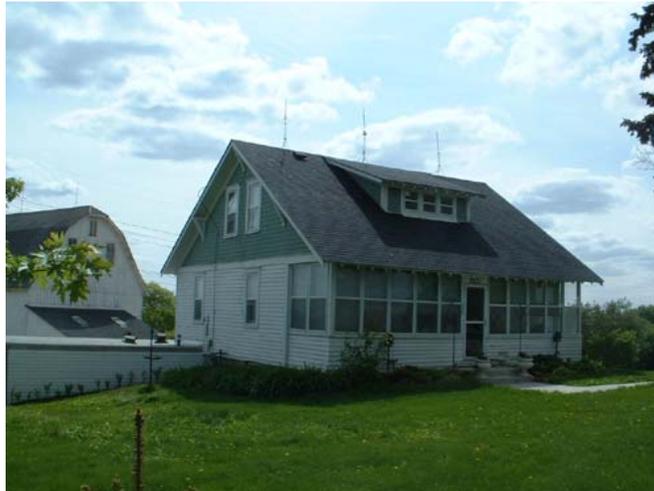
Property 4, House

4	9231 Audubon Rd.	Farmstead	House, Dairy Barn, Garages	c. 1920	The Craftsman-style bungalow retains most of the original architectural features and has a rear addition. The jerkinhead, gambrel dairy barn has board and batten siding, and a concrete block foundation has good integrity. A modern garage and a c. 1920 garage are also included with this property.
5	9715 Audubon	Farmstead	House, Barn (converted to house), Garage, Pole Barn	c. 1910	The one-and-a-half story, front-gabled house retains good integrity. Another house on the property appears to have been converted from a concrete block barn. Other buildings include a garage and a metal pole barn.

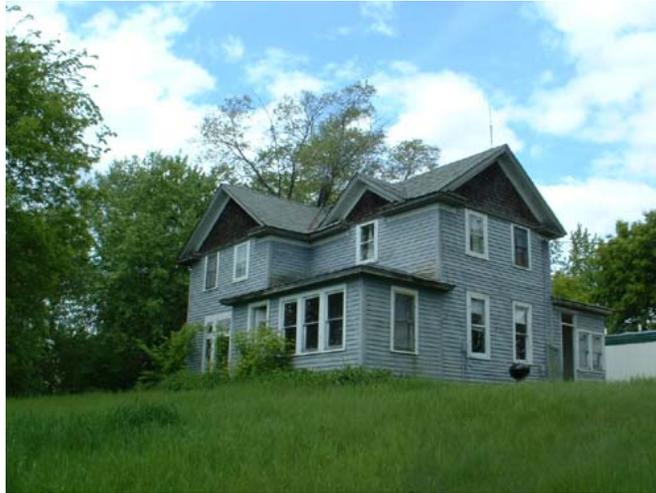
Property 6, House

Due to its proximity to Chaska, this area is known for its houses constructed of Chaska brick, a distinctive cream-colored brick associated with the region. Three previously recorded properties constructed in the 1890s, located just north of the project area (see Figure 2), are examples of the use of Chaska brick. None of the properties located within the study area utilized this building material. Most farmsteads exhibit building types commonly constructed during the 1910s and 1920s. One exception is Property 6 (1600 Pioneer Trail), which features a Queen Anne style house, more typical of the late nineteenth century.

Field Number	Address	Property Type	Building Types	Date (Estimate)	Description/Integrity
6	1600 Pioneer Trail	Farmstead	House, Granary/Corncrib, Silos, Corncrib, Trailer Offices, Spring House (?)	c. 1890	The two-story house features massing and detailing of the Queen Anne style. Although some alterations have been made, it retains good integrity despite its dilapidated state. Other outbuildings, such as the garage, chicken house, granary, and corncrib retain good-to-fair integrity but are also dilapidated. The original barn has been demolished, with only the foundation and two adjacent silos remaining. A concrete block structure is believed to have been a springhouse. Modern trailer offices have been added to the site. The farmstead as a whole does not retain integrity.
7	1500 Pioneer Trail	Farmstead	House, Quonset Barn, Pole Barns, Butler Bins, Harvestore	c. 1910	The foursquare house has been clad with aluminum siding and has had other alterations, resulting in poor integrity. The original barn appears to have been replaced with the addition of a Quonset shed on the original foundations. Other metal pole barns, Butler bins, Harvestore silo have been added to the farmstead, resulting in poor overall historical integrity.

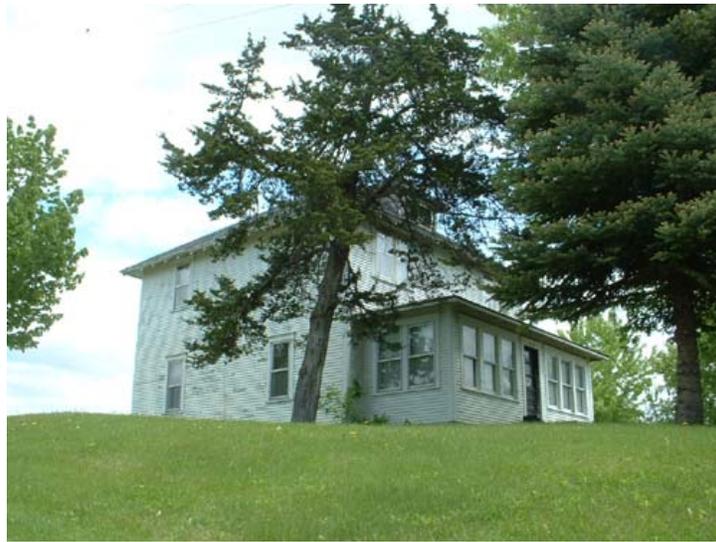
Property 8, House

8	1370 Pioneer Trail	Farmstead	House, Dairy Barn, Granary, Pole Barn	c. 1910	The foursquare house has wooden clapboard siding and retains good integrity. The gambrel-roof dairy barn has board and batten siding and retains good integrity. Other buildings include a partially demolished granary and a metal pole barn.
